Waste Delineation and Characterization, Makah Landfill, Neah Bay, Washington

# WASTE DELINEATION AND CHARACTERIZATION

## MAKAH LANDFILL NEAH BAY, WASHINGTON

DECEMBER, 1995

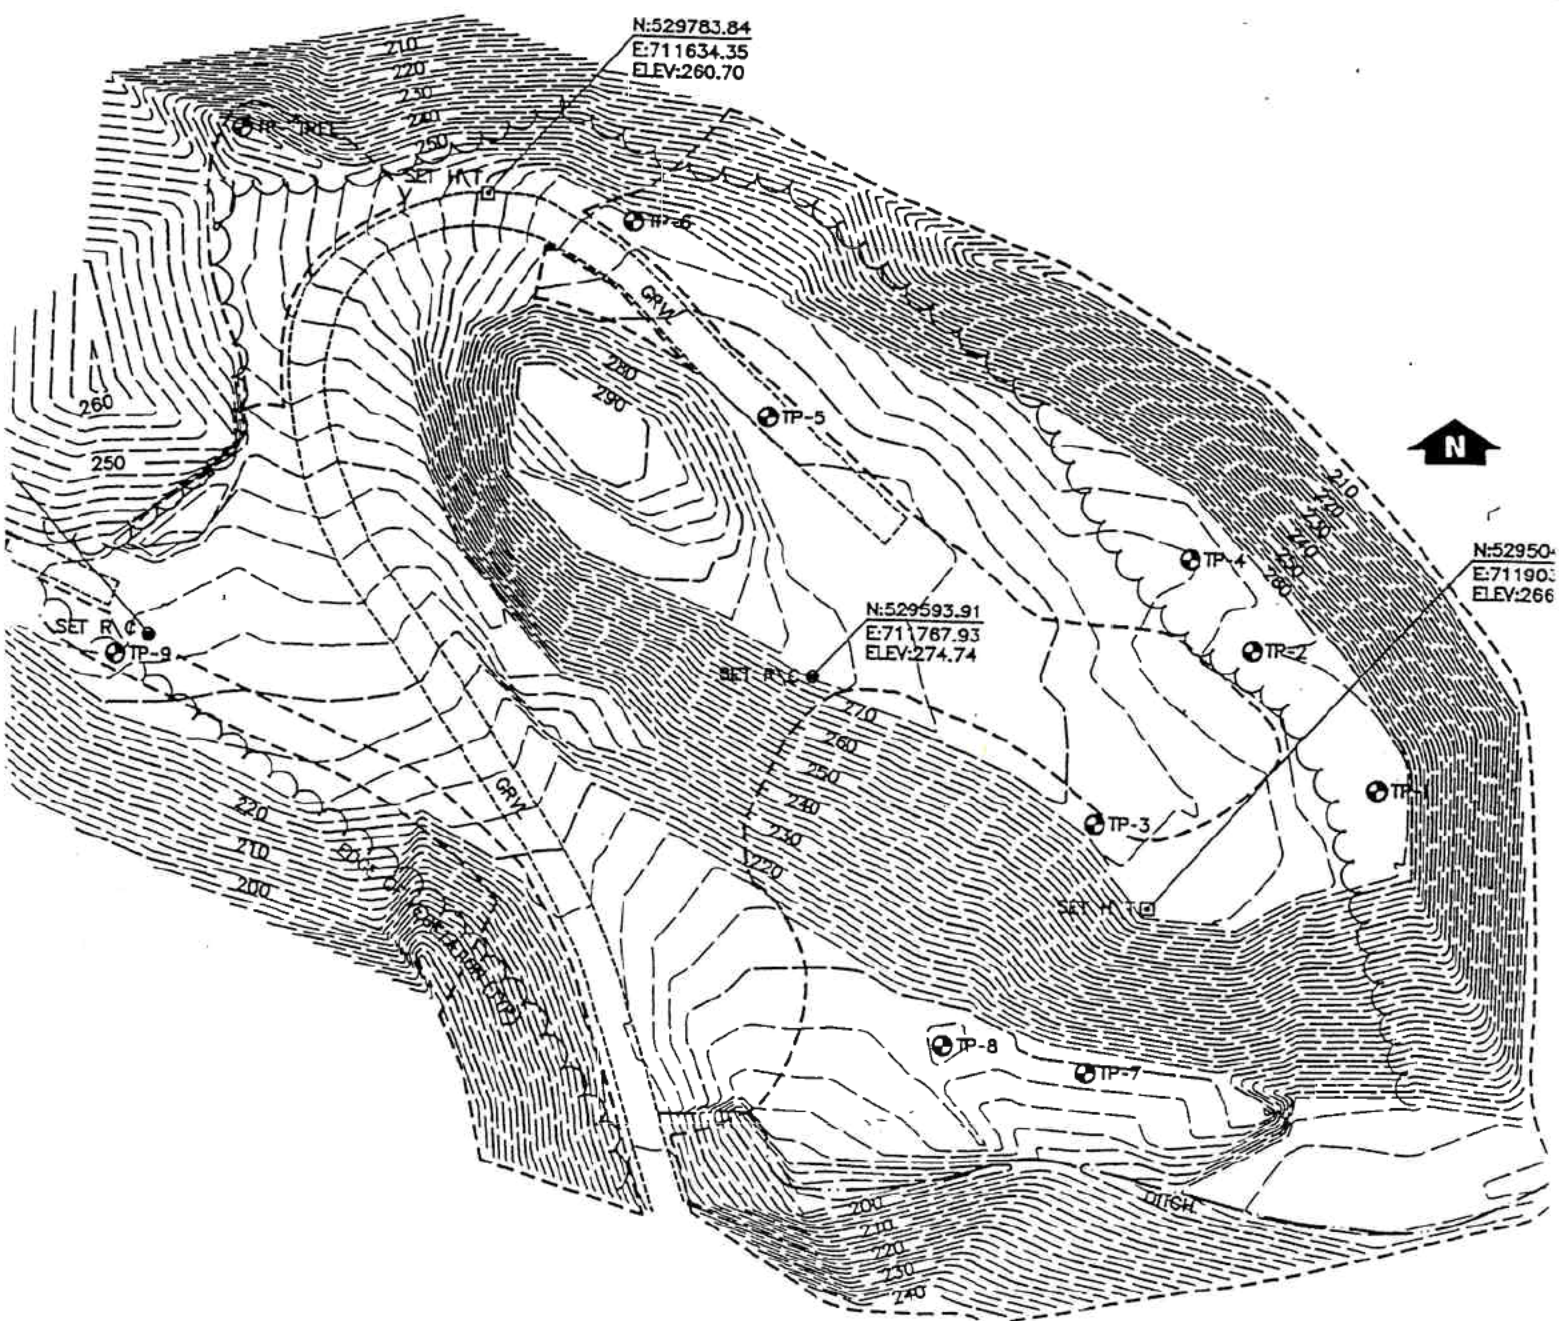
FIGURE 2: SITE MAP

The site has been mapped topographically and the visible extent of the garbage as it was the 7th and 8th of November 1995 has been plotted on the site map (Figure 2). The site is active and material is added and moved on a continual basis, so the volume and exact location of the waste material will vary somewhat from that shown in Figure 2.

Nine test pits were excavated November 7 using a 225 Trackhoe to depths which either reached the native soils or to a depth of 22' (22' is the maximum reach of the trackhoe) and the location of these pits is shown on Figure 2. Fifteen samples were collected for material or soil characterization purposes. An additional sample of roofing material on site was collected for analysis for asbestos materials.

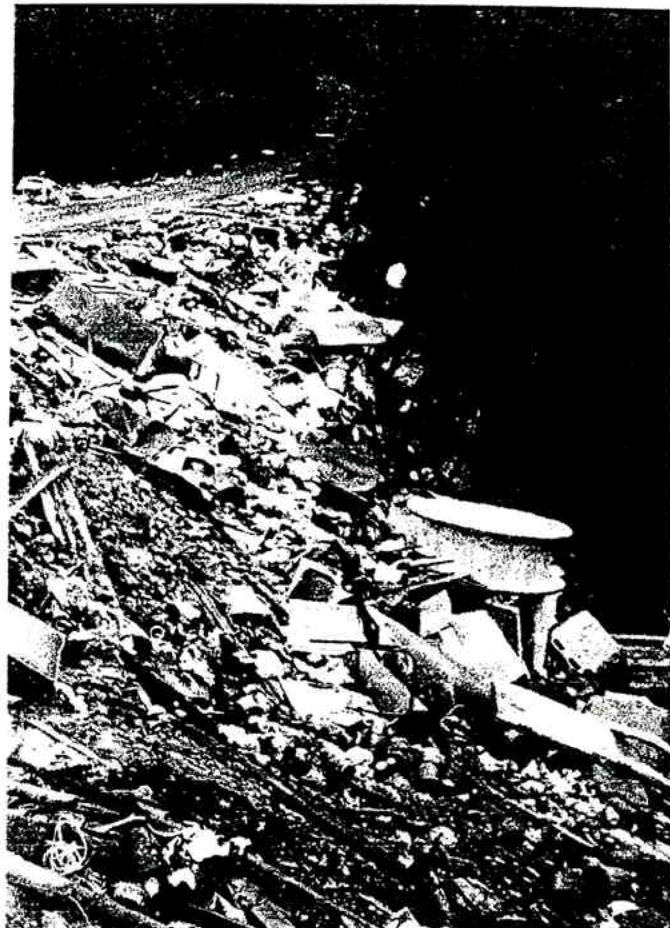
PHOTOGRAPH 9: WEST SIDE OF ACCESS ROAD, LOOKING W, SW.

The hill is composed of a very coarse, gravel and sand conglomerate which readily weathers to a sandy gravel. There is an outcrop of black shale west of the road and north of the location of TP-9 which may be of sufficient size and quality for use as landfill cover material.
